Manhole Inspection Summary

Manhole # S29CC1033MH

Insp Date: **12/13/06 3:30 PM**

Location Address: **37TH ST**

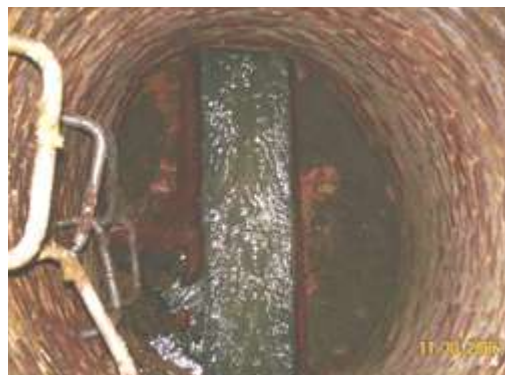
Top View

Bench debris.

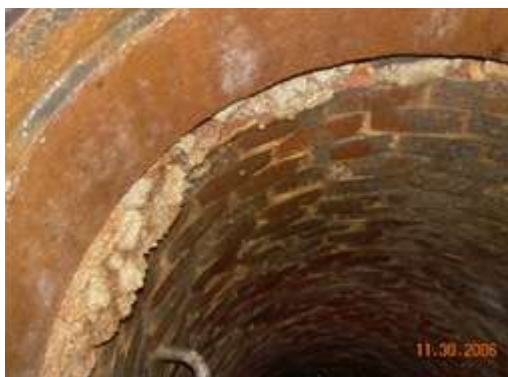
Defect

Infiltration: ☐ None ☒ **Joint** ☐ Cracks ☒ **Mortar** ☐ Roots ☒ **Wall**

Infiltration: ☐ None ☐ Joint ☐ Cracks ☐ Mortar ☐ Roots ☒ **Wall**

Frame leaks. Corbel and Barrel infiltration.

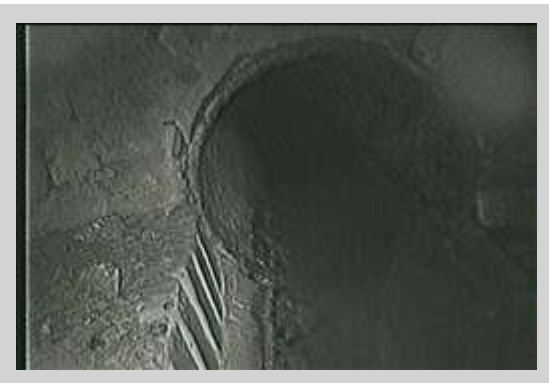
15 in. Circular Gravity Sewer Pipe In @ 6 O'Clock

Infiltration: **Evidence** Pipe Seal Cond: **Cracked**

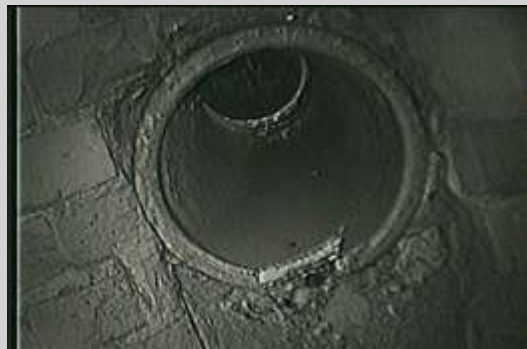
Pipe In @ 7 O'Clock

Infiltration: **Weeper**

Pipe Seal Cond: **Broken**

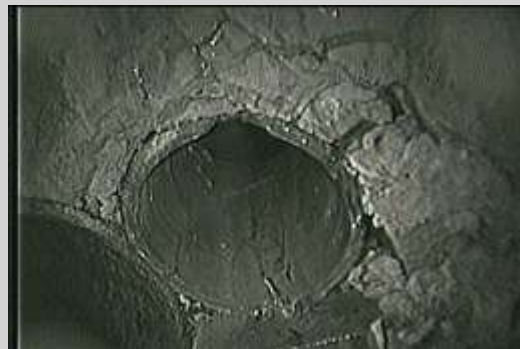
Drop In @ 7 O'Clock

Drop: **Outside** Rod and Bar

Drop Condition: **Open**
